Archangelos Michael Church in Lefkonoiko/Gecitkale

PROJECT OVERVIEW

Type of intervention: **Consolidation and Conservation works**

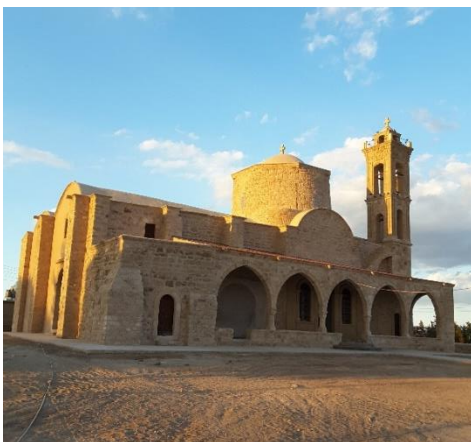
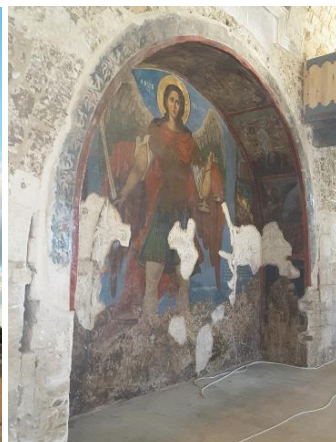
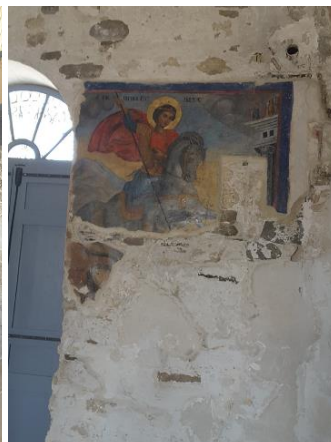
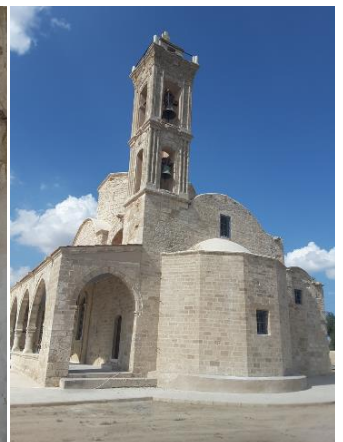
The main **structural interventions** aimed at consolidating and stabilising the church in order to bring the building, to the maximum degree possible, to its original state. The church benefited from a major structural consolidation of walls, vaults, arches and dome with some tie rods stitching and extensive injection grouting. The dome was repaired, cracks were bridged with tie rods and filled with grouting. The belfry was consolidated and repaired in situ. The roof of the church was returned to its original barrel shape with repairs and waterproofing. The south portico's roof was reconstructed. Original doors and windows were restored and/or reconstructed.

A **painting of Archangelos Michael**, to whom the church is devoted, covers the whole wall of the blind arch. An older fresco was discovered during the works on the intrados of the blind arch of the south wall; repaired and stabilised. This fresco is now visible to the public and protected by a glass case. Inside the church, frescoes were stabilised and protected, the altar repaired, the iconostasis wooden poles restored, as well as the gynaikonitis (women's gallery) carved wooden floor. The floor was retained and missing floor elements installed.

Externally, perimeter walls were repaired and the missing parts were reconstructed; entrances were gated and access for persons with disabilities was made possible from the gate on the north side of the church. The courtyard was cleaned, graded and compacted for rainwater management. The old school building adjacent the church was also repaired and a roof was provided.
